## **CELDAR** ® TECHNOLOGY

## Case history

## **EMULSION BREAKING AUTOMOTIVE INDUSTRY**

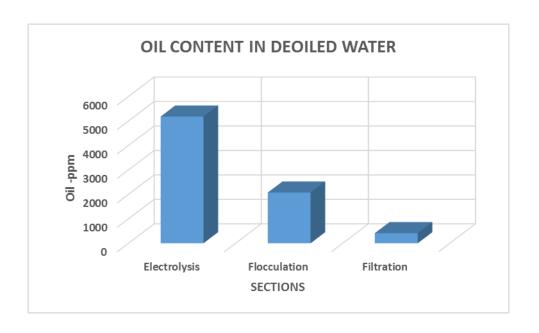
The graph shows the analysis of the oil content in the de-oiled water

AS IT	After 60 min. Electrolytic cell	Flocculation	Filtration	REMOVAL
рН		8,8	7,9	8,2	8,5	
Conductivity	milliSiemens	6,7	6,9	6,8	6,9	
COD	ppm	127000,0	55880,0	11176,0	2235,2	98,24
Oil content in emulsion		37000,0				
Oil content in deoiled water	ppm		5180,0	2072,0	414,4	92,00
Oil in floating layer	%	65,0				
Water recovered	%	86,0
